# AIRFIELD PAVEMENT EVALUATION

KING SALMON  
AIRPORT,  
ALASKA

MARCH 1992

HQ AFCESA PAVEMENT EVALUATION TEAM

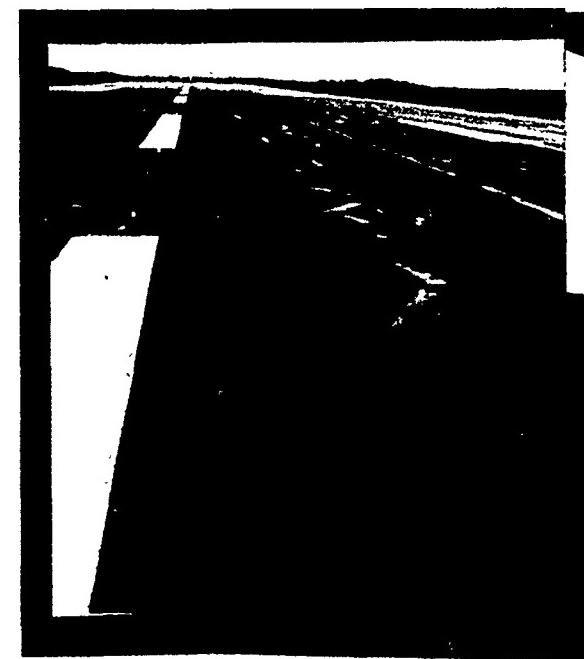
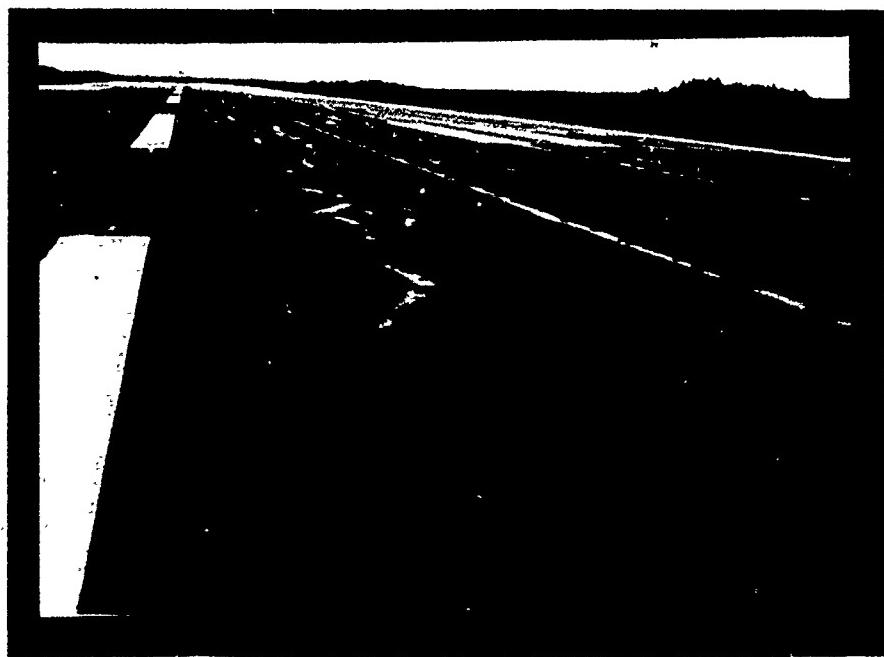
small area with raveled asphalt was observed about 1300 feet from the 11 end (Photo 11). The other half of the runway is in GOOD condition, with block cracking (Photo 12). Most of the asphalt cracks were sealed recently, which is one reason the condition rating is as good as it is.

PHOTO 12; TYPICAL BLOCK CRACKING ON THE RUNWAY. CRACKS HAVE BEEN SEALED.

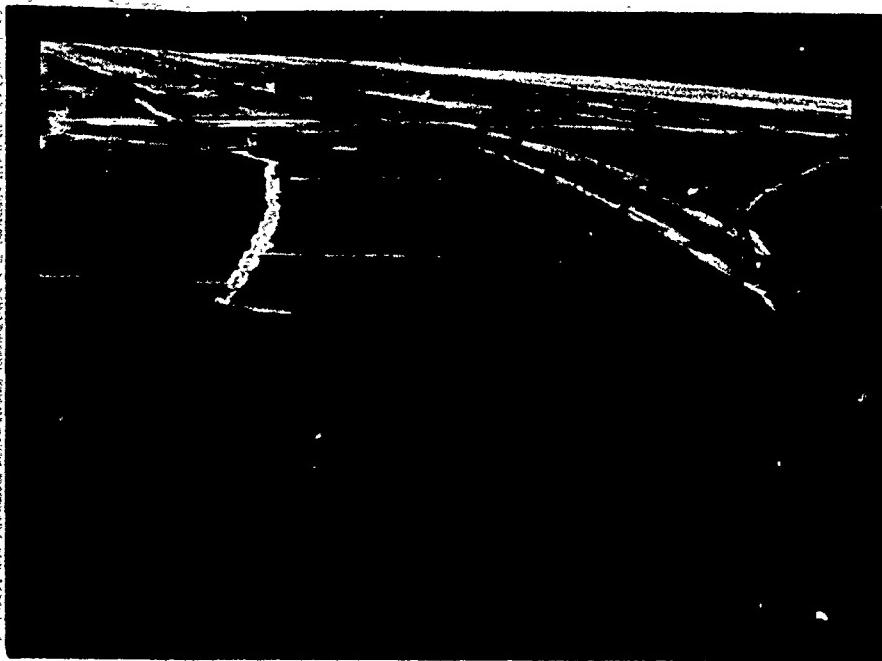
The Elephant Ear Apron is in GOOD condition. The predominant distresses are the typical longitudinal and transverse cracks which have been sealed (Photo 14).

PHOTO 14: SEALED TRANSVERSE AND LONGITUDINAL CRACKS ON THE ELEPHANT EAR APRON.
